National Register of Historic Places Inventory—Nomination Form

s in <i>How to Complete Na</i> —complete applicable s			
1. Nam	e			
historic Kel	ton House			
and/or common	Kelton, Curtis,	or Pyatt House		
2. Loca	ation			
street & number	Corner of Misson	uri Highway 38 4	Church Street	not for publication
	ctville	vicinity of	congressional districts	
state Missou		29 county	Wright	code 229

Continuation sheet Kelton House

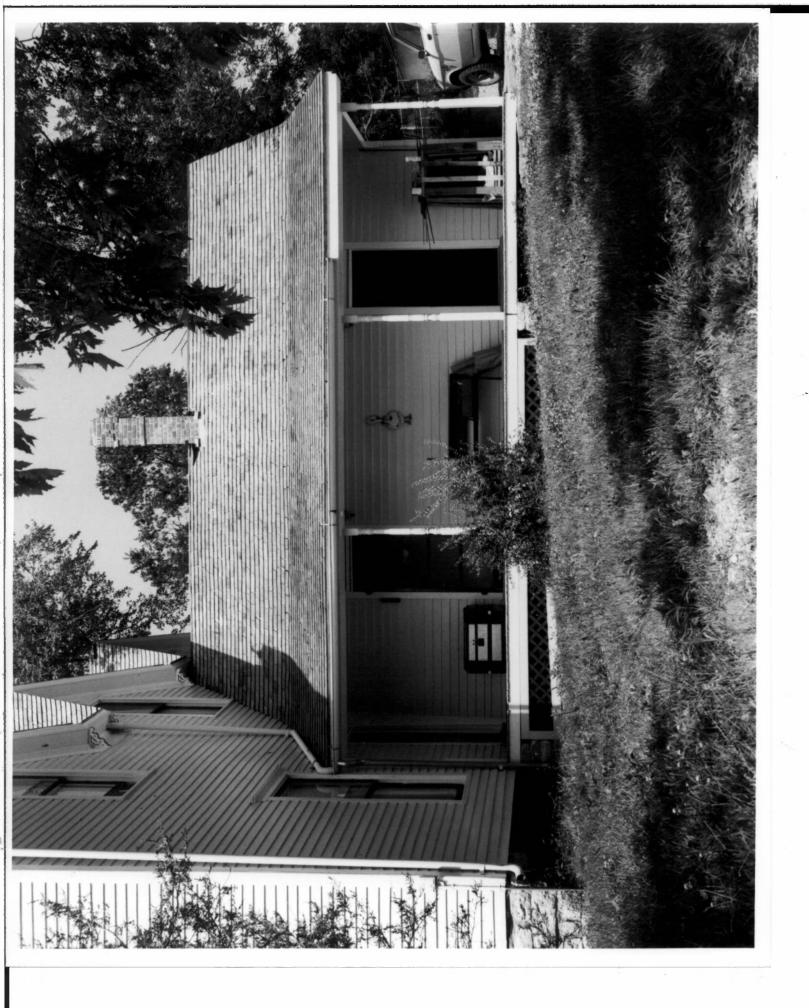
KELTON HOUSE 4-14

Facing West; Detail of Mansard. Note: the intersection of mansard and wall dormer.

Other exterior details are consistent with a three part sequence of construction, for instance, the triangular wall dormers above the two south verandas are abruptly interrupted by the south mansard. These

remaining dormers echo three on the north side of the central block. This suggests the central block pre-existed the southern projection as well as the north ell.
